# Almost a 'Deadman's' Handle

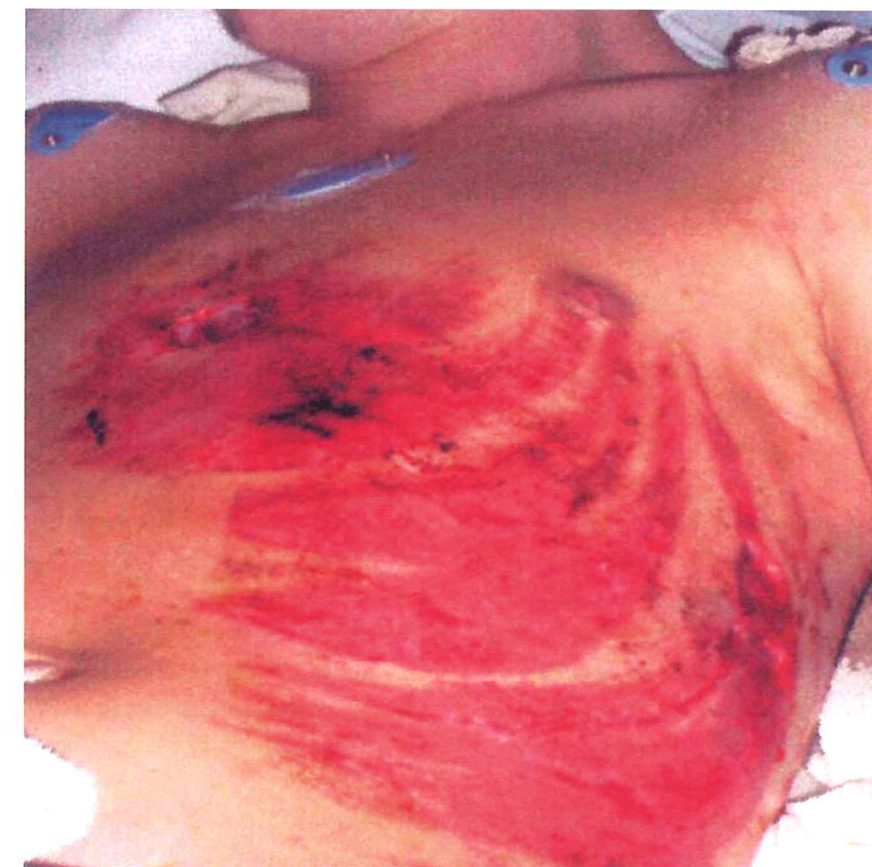
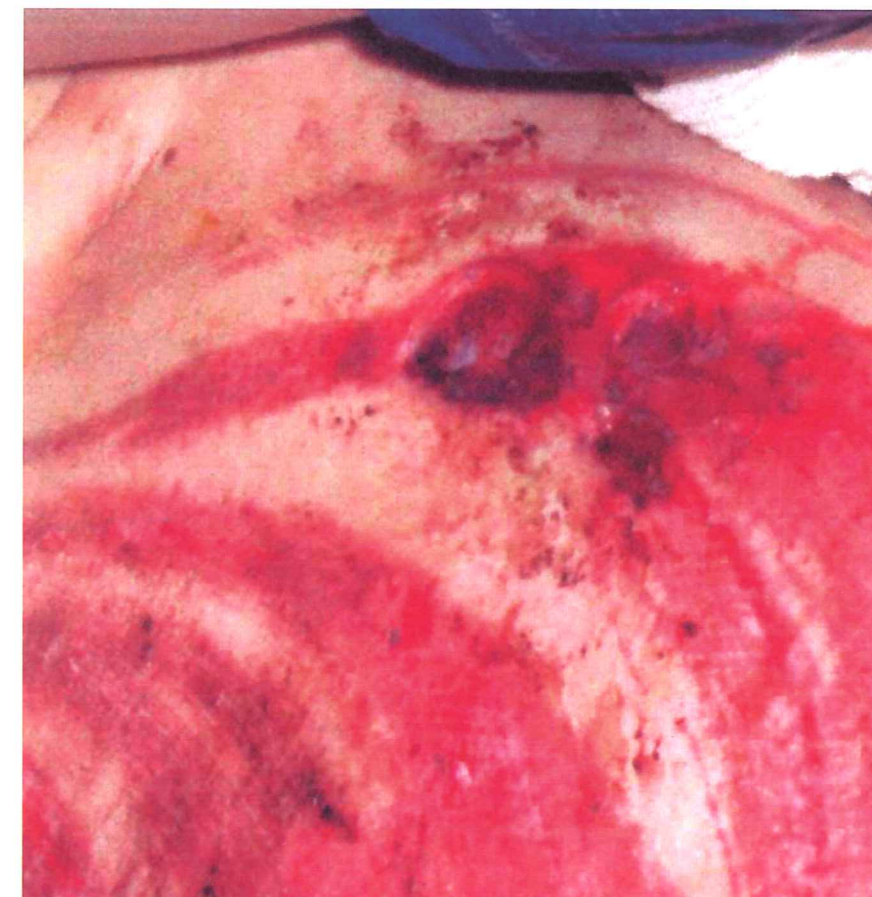
Fortunately, the accident was seen by another powerboat in the vicinity, which managed to pass a line to the people in the water and tow them clear. The injured passenger sustained deep lacerations to his chest and left side (Figures 2 and 3), and was taken to hospital by air ambulance. He remained hospitalised for 3 weeks. The RIB, escorted by a local lifeboat, circled for about 30 minutes until it finally beached in an area which had been cleared of many other, varied activities by local authority officials. The flares carried on board the RIB were found to be out of date.

Figures 2 and 3 – Injuries to passenger
